Avoidable Accidents No. 5

Starved and exhausted: Fuel management aviation accidents

Report No. AR-2011-112**Publication date** reprinted March 2013**ISBN** 978-1-74251-293-8**Publishing information**

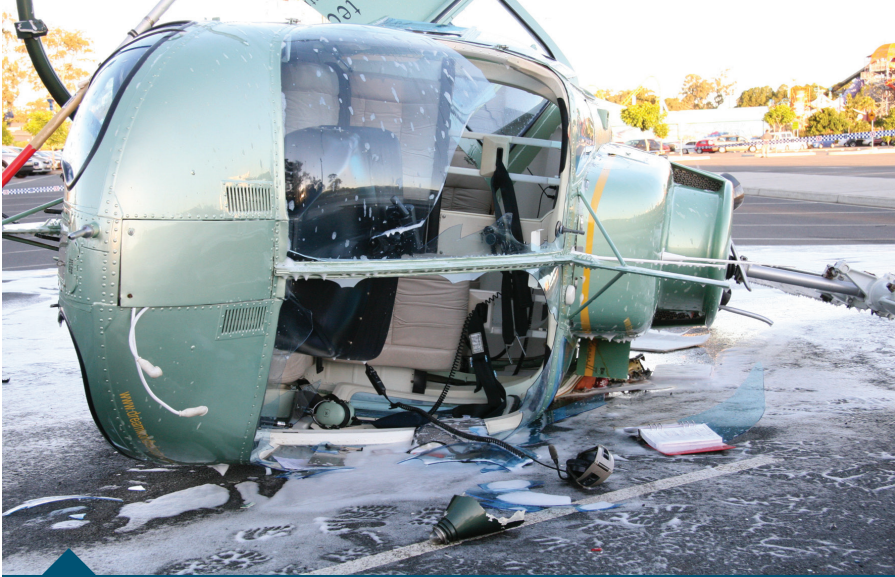
Wreckage of the Bell 206 helicopter

In June 2009, a Bell 206 helicopter was five minutes short of its destination with a pilot and four passengers on board, when a fuel boost pump low pressure warning light illuminated briefly. The pilot believed there was sufficient fuel to complete the flight, and continued until the power failed. The pilot then conducted an autorotative landing, however, the high rate of descent caused substantial damage to the helicopter and injuries to some of the occupants. A passenger took a photograph during the landing which showed the fuel quantity gauge indicating there was still fuel available, however fuel exhaustion had occurred.

A subsequent check of the helicopter and its fuel system showed that the fuel gauge may have been over-reading. The operator's practice when calculating the quantity of fuel to be added during refuelling relied on the fuel gauge reading, without using an independent method to crosscheck that reading against the actual fuel tank quantity.

Because the pilot was only relying on the fuel quantity gauge to assess fuel quantity, he would not have known if the fuel quantity indication had become faulty. Without a cross-check from a second source of fuel quantity information, the pilot had no assurance that the information was correct and could not assume that the gauge indication was the correct quantity of fuel remaining.

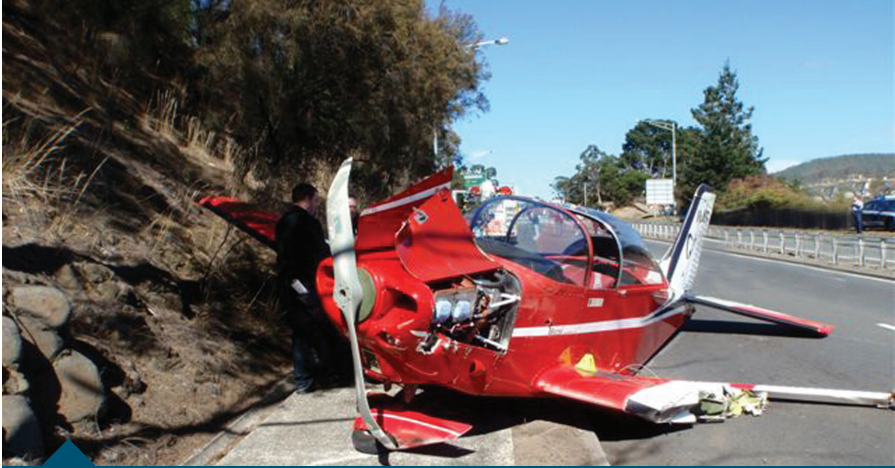
Wreckage of the Victa Airtourer

In April 2010, a Victa Airtourer was conducting its fifth flight since refuelling, when the engine lost power due to fuel exhaustion. The pilot conducted a forced landing onto a road, resulting in substantial damage to the aircraft but no injury to the pilot, the only person on board. The pilot reported that he had used a dipstick to assess that there was sufficient fuel for the flight, and that the fuel quantity indicator provided a similar indication of fuel quantity, showing the tank was about half full. Unfortunately, the pilot used an incorrect (but not uncommon) method of using the dipstick that resulted in an over-reading of the fuel onboard. Furthermore, a close inspection of the aircraft's flight and fuel log would have revealed that the fuel gauge and the dipstick indications showed a fuel usage that was half the expected usage.

The ATSB investigation revealed that a number of factors worked against the pilot involved in this fuel exhaustion accident, some of which were outside his control.

Cross-checking the dipstick reading against the fuel gauge indication was an effective method for spotting errors, however, a quick mental calculation would have shown a significant discrepancy between the indicated fuel quantity and the expected fuel usage. The discrepancy could have alerted the pilot that something was wrong with the available fuel quantity information.

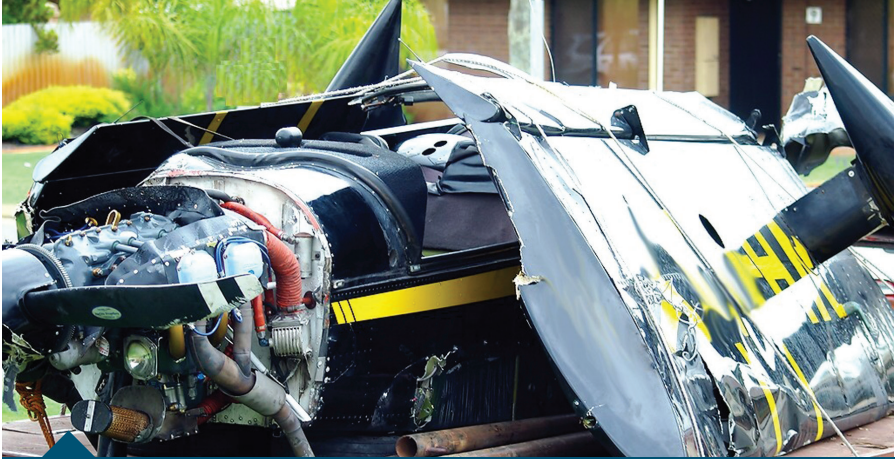
Wreckage of the Robin 2160 aircraft

In March 2005, a Robin 2160 aircraft was returning from a flight to break in a newly overhauled engine. Shortly before arriving at the destination aerodrome, the engine lost power and the aircraft crashed on a suburban street. The pilot escaped with minor injuries and reported that he had been using higher power settings for the engine run-in, however, the pilot had used the fuel consumption rate for normal power settings. The aircraft ran out of fuel at a time that was consistent with fuel usage at the higher power settings.

Aircraft flight manuals often provide data that shows the fuel consumption rate at standard power settings with the mixture leaned. If those settings are used, an assessment of the fuel remaining should be correct. However, even small changes in engine operating technique, such as leaning or a small increase in rpm, can make a big difference to fuel flow.

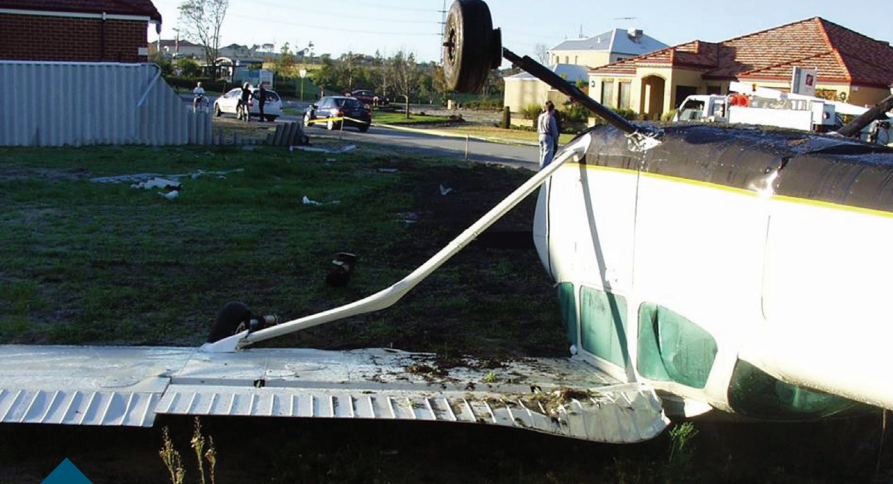
Accident site of the Cessna 172 aircraft

In June 2001, a Cessna 172 was being flown south along the West Australian coast to Perth. The pilot refuelled at Geraldton with sufficient fuel for the trip. Forty-five minutes after departure, the pilot returned to Geraldton because of bad weather en route. Later that day, when the weather improved, the pilot took off again and flew to Jandakot Airport, near Perth. The pilot reported that he experienced strong headwinds during the flight. The engine lost power because the aircraft ran out of fuel shortly before reaching its destination, and crashed during a forced landing in a suburban area.

Flights are planned on the basis of expected en route conditions. Monitoring a flight's progress allows a pilot to assess if the flight is maintaining an adequate fuel reserve, and to make timely decisions if the flight conditions change.

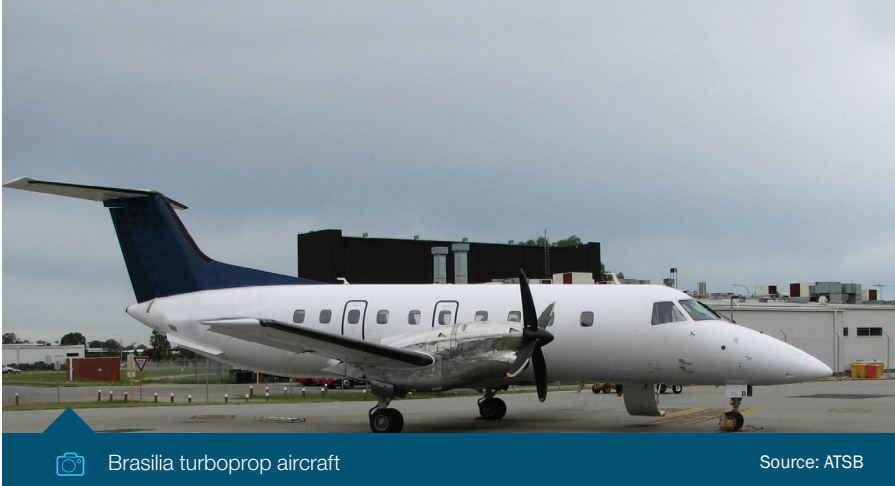
In June 2007, a Brasilia turboprop aircraft conducting a charter flight with 31 people on board lost power from its left engine shortly before landing at its destination. The flight crew conducted a missed approach and landed about 12 minutes later.

The fuel tank supplying the left engine had no fuel remaining, and the fuel quantity indicator was over-reading because of a mechanical defect. Other methods of calculating the fuel quantity existed, but were not used effectively.

Various methods were available to assess fuel quantity on this aircraft, however, the methods had been modified so they were all based on information that was originally derived from the fuel quantity indicator. The undue reliance placed on the accuracy and reliability of the fuel quantity indicating system meant that when the fuel quantity indicating system became faulty, the flight crews were not aware of the potential for engine fuel starvation. Cross-checking the fuel quantity indicating system with the 'dripless measuring sticks' installed on the aircraft before flight would have highlighted the problem.

Accurate knowledge of fuel quantity at the start of a flight is essential for any fuel-critical operation. All subsequent assessments are derived from that initial number. If only one fuel quantity measurement is used, then it is not possible to find out if that system is working properly because you have nothing to compare your information against.

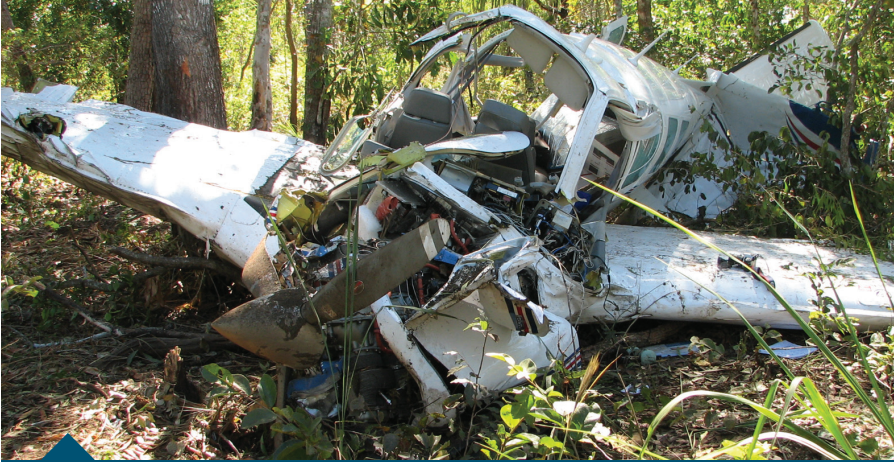
Accident site of the Beechcraft A36 Bonanza aircraft

In June 2006, a Beechcraft A36 Bonanza was conducting a private flight from Kununurra, West Australia, to Bathurst Island, Northern Territory, with one person on board. The aircraft crashed in woodland about 1 km short of the runway at Bathurst Island. The pilot, who was the only occupant, was fatally injured.

The aircraft was equipped with four fuel tanks, two main tanks, one in each wing, and one tip tank in each wing, with the use of the tip tanks restricted to level flight only. There was evidence from the wreckage that there had been sufficient fuel in each of the main tanks. The pilot had a written a fuel log indicating the left tip tank had been selected on reaching cruise altitude, and the right tip tank selected when the left tip tank was nearly empty. It is likely that the pilot omitted to select a main tank before descending from cruise altitude, and the right tip tank ran dry at a low altitude with insufficient time available to restore fuel supply to the engine.

Although the tip tanks had been used during the cruise and a fuel log confirmed the fact, the use of a pre-descent checklist to ensure that the correct tank was selected well before approaching the ground could have reduced the chance of this starvation event. Running dry at a low altitude reduced the opportunity to recover from the power loss.

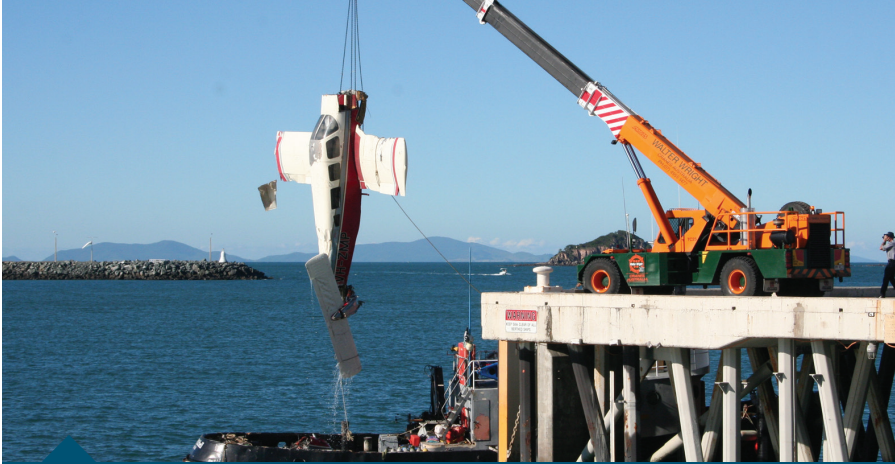
Wreckage of the Piper Cherokee Six aircraft

In April 2008, a Piper Cherokee Six aircraft was conducting inter-island charter operations between Mackay and the Whitsunday Islands ferrying tourists. The flight was just taking off for the last of six flights since refuelling to return to Mackay with the pilot and four passengers on board, when the engine lost power and the pilot ditched the aircraft. None of the occupants were badly injured and they were rescued from the water by helicopter.

This aircraft used four fuel tanks, two main tanks and two wing tip tanks. Fuel could only be drawn from one tank at any one time. The company fuel policy was to carry flight fuel in the tip tanks and to alternate between the tip tanks with each flight. Reserve fuel was carried separately in the main tanks.

The operator's fuel management system appeared to be logically safe, however, it resulted in the last takeoff being conducted with the fuel supply not being selected from the tank with the greatest quantity of fuel. There was little margin for error because the flights were planned to consume nearly all the flight fuel, and there was a greater potential for flight variation with six takeoffs and landings between refuelling. The quantity of fuel remaining in the selected tip tank could have been affected by increased fuel flow or increased flight durations, or incorrect fuel tank selection. The system was also not error-tolerant, because the flights were conducted at relatively low altitude. This meant that in the event of a power interruption due to a tip tank running dry, little time was available for the pilot to switch to one of the main tanks to restore fuel flow to the engine.

The more tanks you have to choose from, the greater the potential to make a mistake and to select the wrong fuel tank. Forgetting to change the fuel selection, or not being sure whether you remembered to change the fuel selection, can be managed by the disciplined use of a fuel log to record fuel usage. A pilot may forget, but if fuel selections are written down, then the fuel log can act as an effective reminder (along with adherence to checklists).

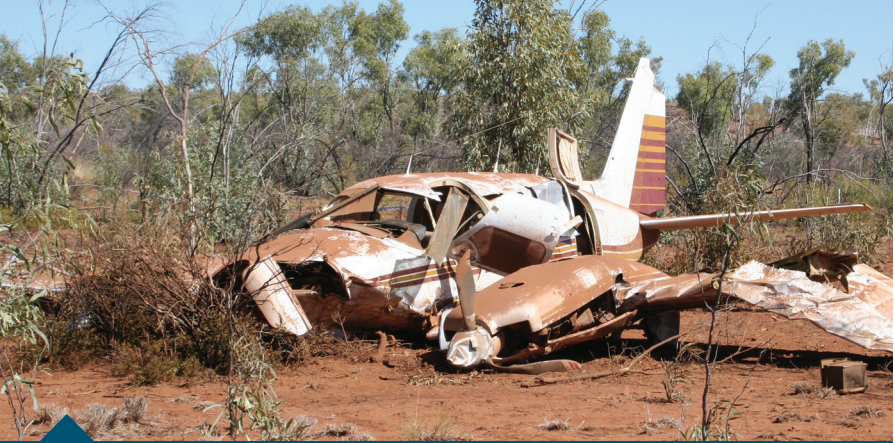
Wreckage of the Piper Navajo PA-31 aircraft

In July 2008, a Piper Navajo PA-31 aircraft had flown a charter operation carrying passengers from Mount Isa Queensland to a mine camp. On the return flight, with only the pilot on board, both engines failed when the aircraft was on descent and about 10 minutes from its destination. The pilot conducted a forced landing in sparsely wooded terrain and sustained serious injuries during the accident sequence.

In this flight, the pilot had selected the outer tanks for use in the cruise, and was planning to use nearly all of the fuel in the outer tanks before selecting the main tanks for the last part of the flight. Although the pilot was expecting to change tanks soon, he was not prepared for the sudden loss of power when the fuel supply to one engine was exhausted. The pilot conducted engine power recovery drills, but did not change the fuel selection to supply fuel from the main tank that still had sufficient fuel remaining. When the second engine lost power, the pilot concentrated on retaining control of the aircraft, and prepared for a forced landing.

After the accident, the fuel supply was still selected from the outer fuel tanks. There was no fuel in either outer tank, however, there was sufficient fuel remaining in each main tank to complete the flight. The pilot reported that he had diagnosed the initial power loss as an engine malfunction, rather than a fuel starvation problem.

The risk of fuel starvation is reduced if the appropriate tank is selected before descending toward the destination after ensuring it also contains adequate fuel for landing. This task is normally conducted during the pre-descent checks for aircraft with more than one tank with good reason, because changing tanks is easily forgotten once you become busier in the circuit pattern.

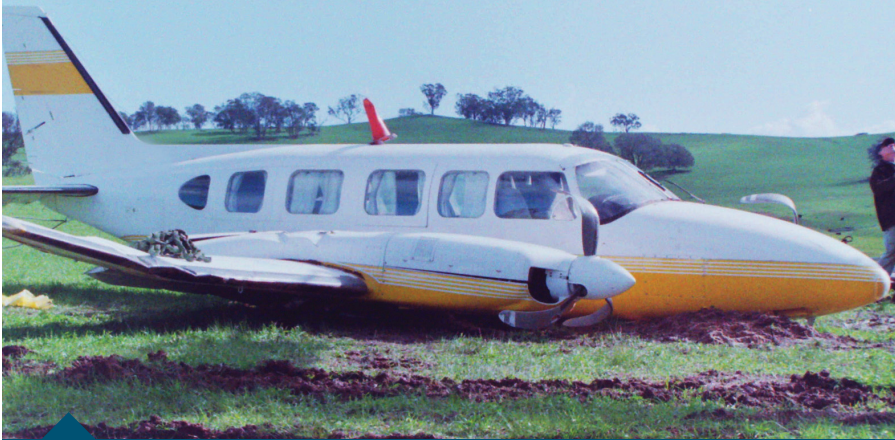
Accident site of the Piper PA31-350 Chieftain aircraft

In August 2003, a Piper PA31-350 Chieftain aircraft departed from Albury Airport for a flight to Bathurst with a pilot and six passengers on board. As the aircraft was climbing through 5,000 ft after departing from Albury, the right low fuel light illuminated and the right engine then lost power. The pilot initiated a diversion to nearby Holbrook Aerodrome, however, about 1 minute later, the left low fuel light illuminated and the left engine also lost power.

The aircraft had the same fuel tank layout as a Piper Navajo, although the cockpit fuel selection controls were different. The main tanks had been filled before the flight and the outer tanks were nearly empty. After the accident, the main tanks were observed to be full, and the outer tanks were empty.

The pilot operating handbook checklist required the fuel selectors to be selected to the main tanks before takeoff. However, it was a normal company procedure to conduct pre-take off engine run-up checks with the fuel selected to the outer tanks, to ensure fuel supply from the outer tanks worked properly before flight.

The circumstances were consistent with the aircraft operating from fuel supplied from the nearly empty outer tanks until those tanks ran dry.

There is a need for good pilot knowledge and proficiency with aircraft systems and procedures, as well as ensuring that pilots are sufficiently trained to ensure that an unexpected fuel management problem can be managed safely, all the way down to a safe landing. However it is preferable that pilots avoid such situations by the use of sound standard operating procedures (SOPs) and the diligent use of checklists.

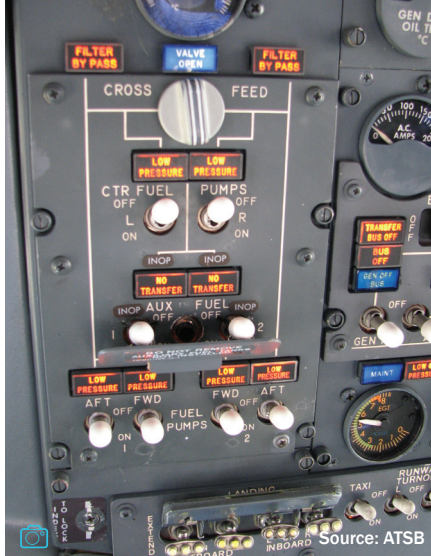
In August 2007, a Boeing 737-400 aircraft was being operated on a scheduled passenger service from Perth, Western Australia to Sydney, New South Wales. About 2 hours 40 minutes into the flight, the master caution light illuminated associated with low output pressure of the aircraft's main (wing) tank fuel pumps. The pilot in command observed that the centre tank fuel pump switches on the forward overhead panel were selected to the OFF position and he immediately selected them to the ON position.

The main fuel tanks were low on fuel and the investigation estimated that there was about 100 kg in each of the main tanks. The centre fuel tank contained about 4,700 kg of fuel when the master caution occurred. The flight continued on the flight planned route and landed at Sydney 51 minutes after the initial illumination of the master caution light.

The investigation determined that a number of factors contributed to the occurrence. However, in common with other incidents described in this publication, the pilots did not notice that the centre tank fuel pump switches were not in the ON position as some pre-flight checklist procedures were not diligently adhered to and the en-route review of the fuel status by the flight crew was ineffective.
